Strategic Replacement of 220 kV Cable at Taranaki Combined Cycle Station

Chin Yit Choo
Contact Energy
Auckland, New Zealand

Dr Frank Anthony Auditoré
LineTech Consulting
Hamilton, New Zealand

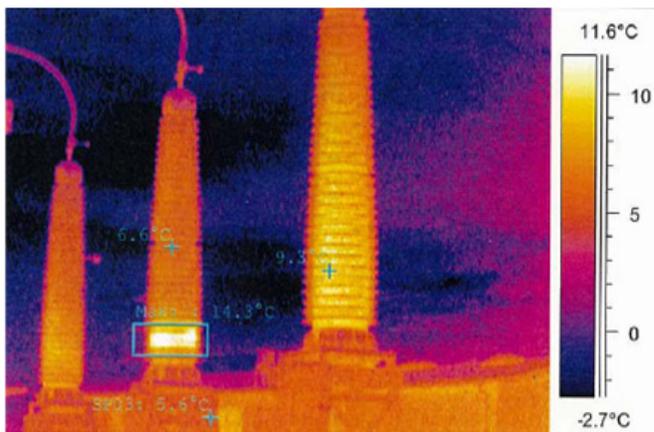
On 7 April 2008, an abnormal temperature distribution on the yellow phase 220kV outdoor sealing end cable located within the Taranaki Combined Cycle (TCC) Power Station switchyard was recorded. The survey was carried out using a thermal imaging camera as part of the condition monitoring program. The result showed 10 degrees Celcius rise over the ambient temperature at that time as shown in Figure 3. The area of concern is generally known to be a high electrical stressed area and is common that the porcelain within this area to be a number of degrees higher than the porcelain near the top. In this case the yellow phase stands up compared to the other two phases which instigated further assessments and analysis.

Figure 3: Temperature Rise On Yellow Phase 220kV Sealing End Cable

An investigation of the abnormal heating revealed a buildup of pressure in the yellow and blue phase of the cable sealing ends. Partial discharge results revealed that an abnormal level of activity was detected on the yellow phase when compared to red and blue phases.

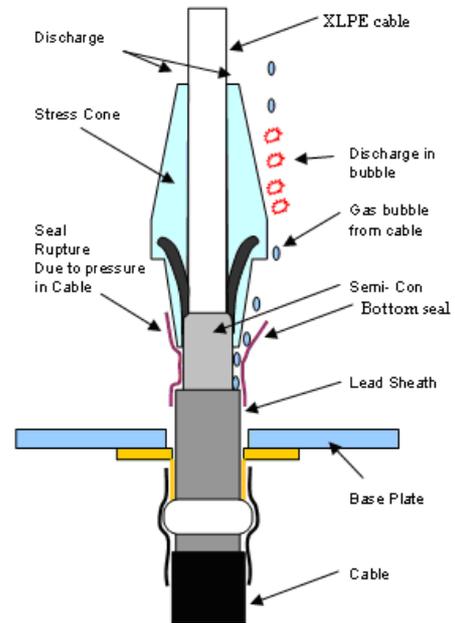
The cable was returned to service and a pressure transmitter was installed in the base plate of the yellow phase termination. The gas pressure in the termination increased again over time indicating that the gas from the cable had again escaped through the cable seal. In theory, if the pressure in the cable is greater than the pressure in the sealing end, this could damage the bottom seal causing gas to leak into the sealing end as illustrated in Figure 4 [1]. As indicated, the gas bubbles could

cause discharging – the possible reason for partial discharging. The repeated buildup of gas pressure led to in-house discussions regarding risk assessments and mitigation measures.

Figure 4: Cable Sealing End Cross Section [1]

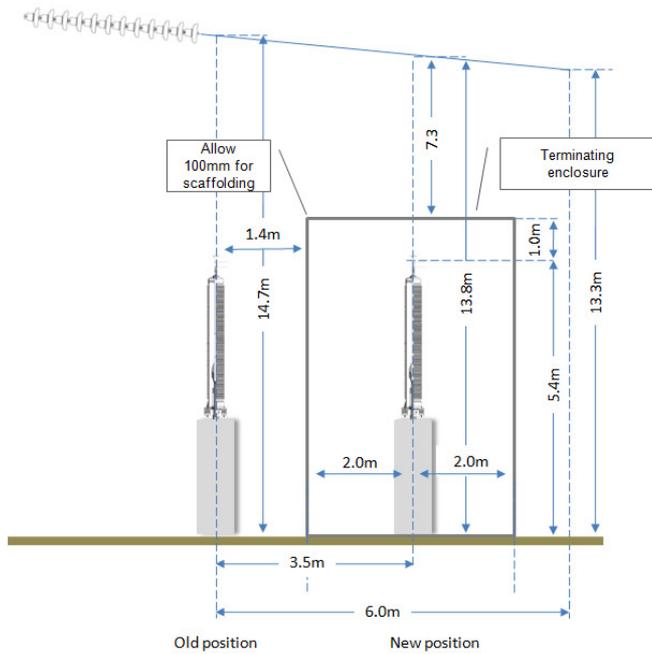
Figure 5: Electrical Clearances for Terminating Cables in TCC HV Yard

To achieve the live working conditions, the foundation within the TCC HV Station was extended by 3.5 m and the sealing end support structures were repositioned by 3.5 m away from the generator transformer. This modification provided the horizontal electrical clearance from the neighbouring isolator. The overhead bypass strain gantry cross-arm in the TCC HV Yard was raised to provide sufficient vertical distance. Actual working dimensions are illustrated in Figure 5. This illustration demarks the terminating enclosure which provided a clean environment for terminating. The greatest installation challenge was to manually raise and position the sealing end porcelain within a 1 m head room.

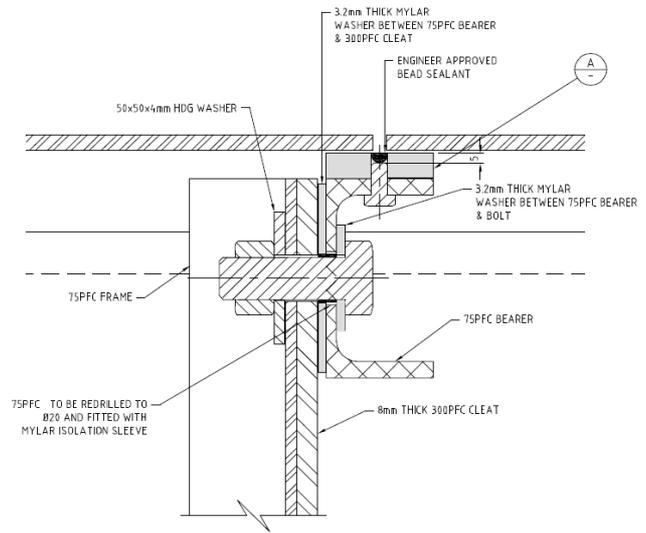
Figure 6: Insulating Steel Platforms

As the cables are enclosed in a metal framework, it was important to design the bridge with insulating platforms for preventing circulating currents. This was achieved by providing

3.2 mm Mylar spacers between the steel walking plates and the metal framework. These are illustrated in Figure 6.

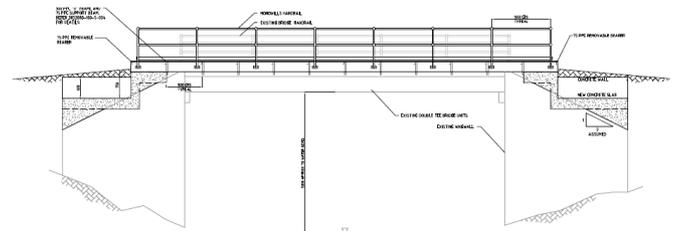
Figure 7: Steel Bridge Modification

A further variation was accommodating the change in thermal movement of the steel bridge as illustrated in Figure 7. The maximum temperature difference between the cable & the stream crossing is assumed to be 30°C above ambient – this is in excess of actual operating conditions as the 220kV cable will be operating at 1010A and it is protected from solar radiation.
