EEA Conference and Exhibition 2008, 20-21 June 2008, Christchurch

PART A
Timber Pile Preservative Injection System.

PART B
**Earth Bonding of Reinforcing Cages
on Older Concrete Poles.**

Wal Marshall

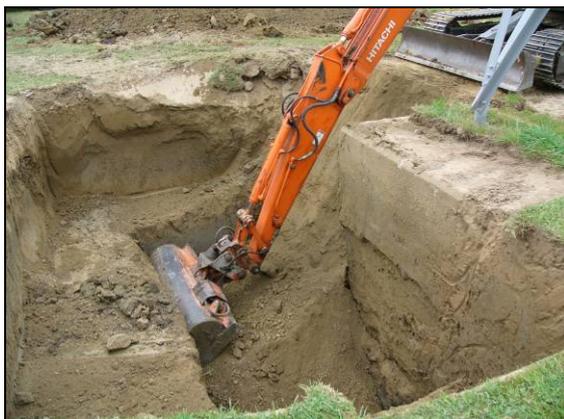
Photo 1: Excavating a foundation.

Transpower has a number of 1930-1960's era transmission line towers built on timber piled foundations. Generally these are located at or close to river or other waterway crossings. The piles are invariably Australian hardwoods, typically ironbark, black butt or spotted gum. The foundations usually consist of three timber piles on each corner of the tower, a total of 12 piles per tower. Each group of three piles is capped with a concrete block approximately 2 m deep, which in turn is bolted to the bottom of the tower leg. **(Photos 1 and 2)**

A sample foundation at the Waikanae River was excavated to ascertain the condition of piles. They were found to be in remarkably good condition considering their age and all were still physically sound. Some piles were solid right through, but a more typical condition was a soft outer layer of about 5-10 mm (30 mm where sapwood had not been removed), a sound timber body of 70- 100 mm or so, then a softer decomposing core of poorer quality heart wood. Sometimes the soft core was dry but more typically it was damp/wet and smelled strongly of alcohol indicating advancing core rot. The upper section of the piles directly beneath the concrete capping was in the worst condition, presumably because it was exposed to the most oxygen.

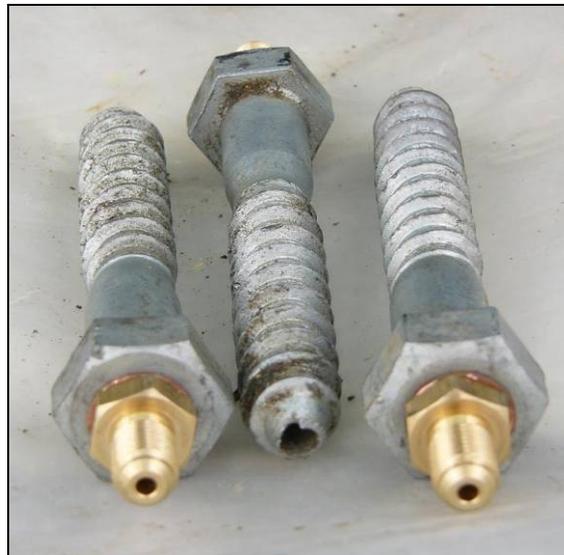
Photo 4: Injection Screws

- a) An injection block bolted to the tower leg. This was a mild steel block with three grease nipples on the top, connected to three outlets on the bottom, bolted to the tower leg with two x 12 mm bolts. **(Photo 3)**
- b) Three injection lines. These were made of approx 3 x 6m lengths of 3/16 inch copper-nickel automotive brake tubing, terminated at each end with line flares and tube nuts.
- c) Three injection screws. These were fabricated from 16 mm coach screws drilled right through and threaded through the head to take a brass adapter and tube nut to terminate the brake line. **(Photo 4)**. The coach screws were installed in 16 mm holes drilled into the side of each pile.

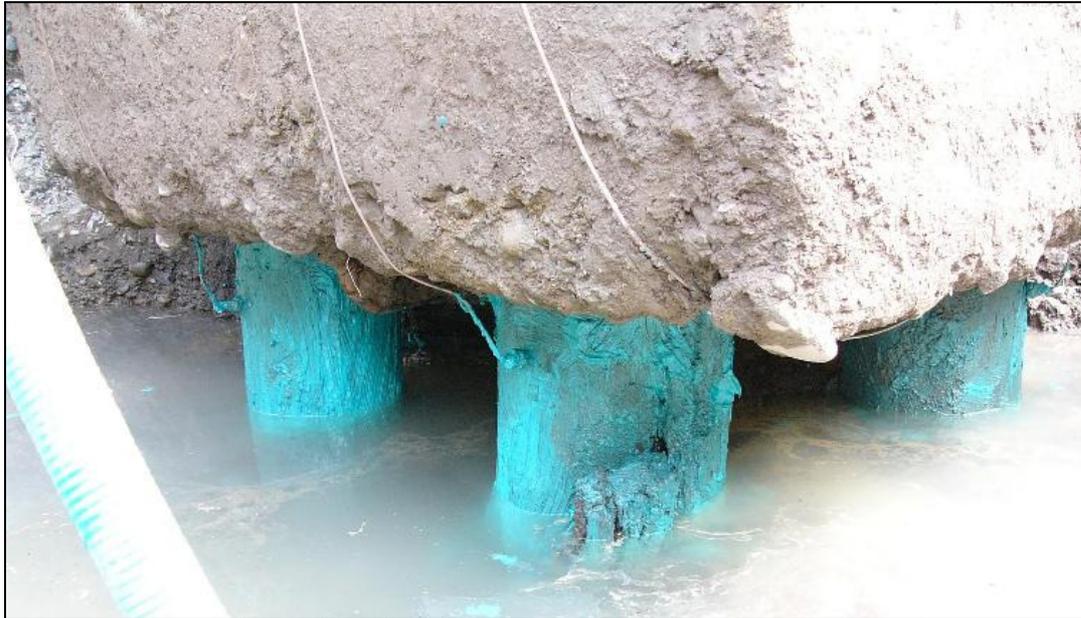
Photo 5: Injection lines installed and external pile surface coated with preservative.

The injection blocks were mounted approximately 800 mm above the tower foundation pad at a comfortable working height. Injection lines were run as a group down the leg, across the pad and down the foundation block tied together with cable ties. The injection nozzles were installed approx 300 mm below the bottom of the concrete pile caps at approx 2-3 m below ground level, depending on the particular foundation. (Concrete depth varied from foundation to foundation). At this depth the injection points are well below the water table level on all

towers even in summer. The total length of line required from injection nozzle to injection block on the tower leg varied from 4 -6 m per pile. **(Photo 5)**

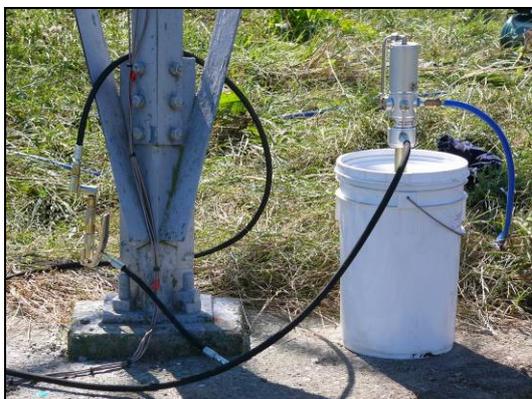
Photo 6: The preservative injection pump.

A compressed air driven grease pump was then purchased to pump the preservative into the piles, and proved to be ideal for the job. **(Photo 6)**. This enabled the CN Emulsion preservative to be drawn directly from the original pails, and injected into the piles under considerable pressure.

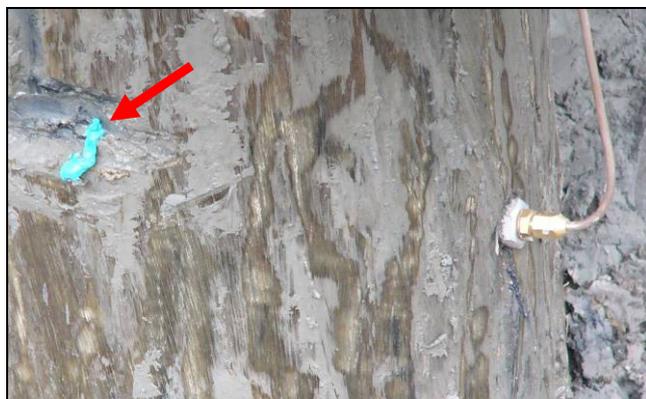
Photo 7: Internal preservative oozing out a grub hole.

1. On approx 50% of the piles pumping refusal was reached, typically between 30-50 strokes of the pump, or about 200 ml of preservative.
2. On approx 30% of the piles, the pile continued to accept preservative even after 50 strokes, but the rate of acceptance was very slow. This typically happened where piles had significant core rot voids and the preservative was slowly forcing it's way into the core of the pile, displacing moisture. Over 500 ml of preservative went into some piles.
3. On approx 20% of the piles preservative continued to feed in at a relatively high rate. Usually this suggested that the pile itself had opened up a split or had other defects enabling preservative to leak out somewhere. These were usually obvious to visual inspection. (**Photo 7**)

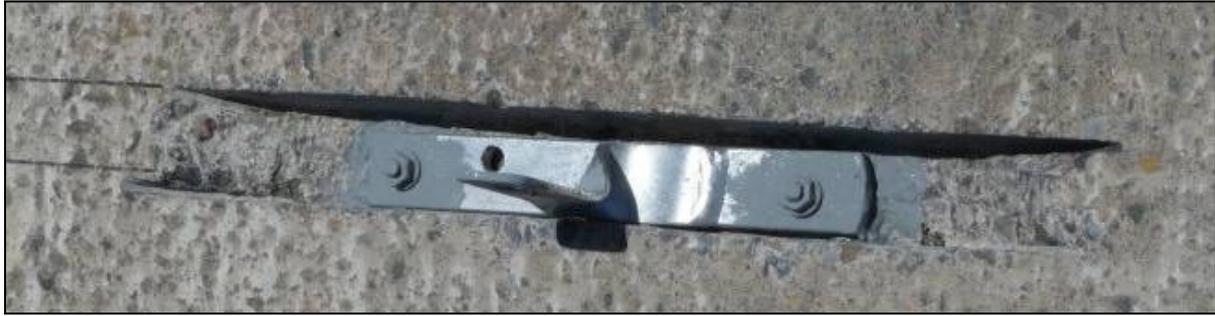
Photo 8: An early prototype bracket installed on a hollow spun pole, prior to reinstatement with mortar.

The pole wall is cut vertically to form a channel approx 35 mm wide, 20 mm deep and about 200 mm long. The concrete is then chipped away to expose two turns of spiral binding. The earthing bracket is then bolted tightly across the exposed binding wire with the contact points impregnated with Transpower 95% zinc rich tower paint to optimise and seal the contact area. The bracket slot is then refilled with high strength quick setting grout. (**Photo 8**)
