EEA Conference and Exhibition 2011, 23-24 June, Auckland

Climbing using Wire Type Fall-Arrest Systems: Why it's the Method of the Future

This paper examines the problems with the dual lanyard attachment method, and explains why permanent wire type fall arrest systems have much better safety outcomes.

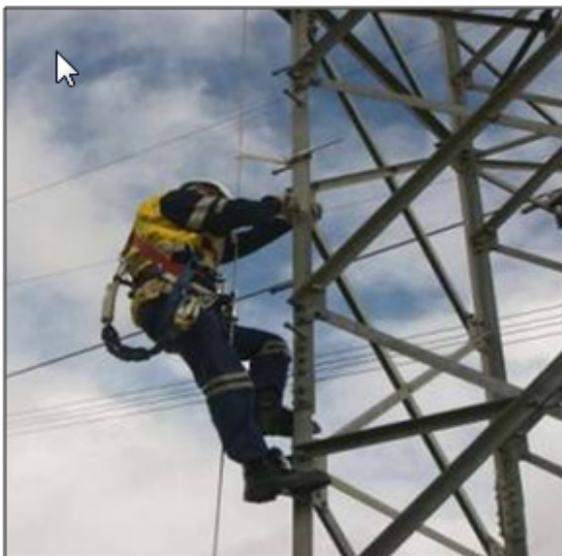
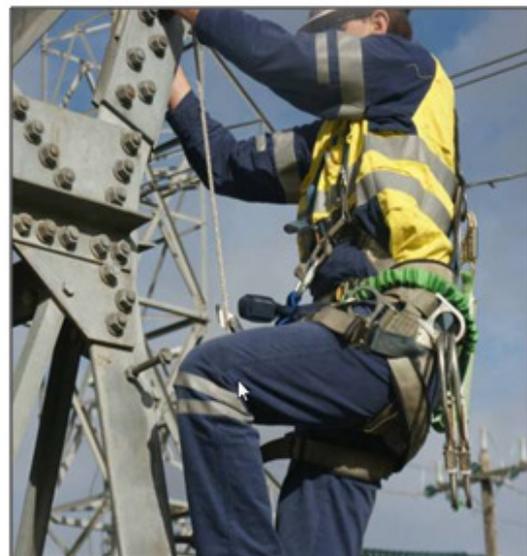
Photos show workers climbing using wire type attachment systems.

Wire attachment systems for towers retain the existing tower climbing steps but add an 8 mm dia stainless steel wire to the outside of the tower climbing leg. The top of the steel wire is attached to a specially designed energy absorbing top anchorage point, and the wire is retained at intervals down the tower with intermediate supports. The lower end is terminated in a bracket which is spring loaded to retain wire tension. The brackets typically mount under the existing climbing step bolts, and position the wire close to the climber’s chest (See pictures on the cover page, and last page).
